Tree Survey: Chesterfield Commerce Centre,
Canal Wharf, Chesterfield.

Client: The East Midlands Chamber of Commerce,
via M John Gill, WMA Architects,
Norfolk House, Sheffield, S2 5HR.

Date of Survey: December 19th to 20th 2016.

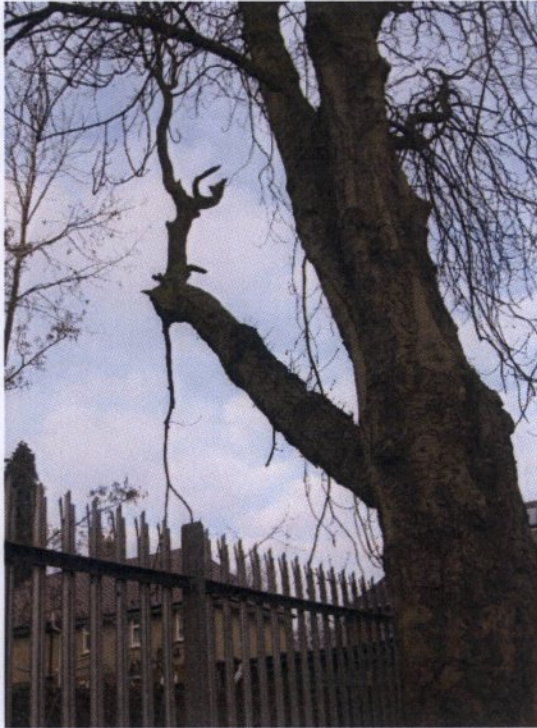
Photograph 1.

8.	Horse Chestnut	18	790	M	C1	OK but has suffered some inexperienced pruning. Has a small lesion that might be Horse Chestnut Bleeding Canker. (See discussion below.) This tree is protected by the TPO.	290

Photograph 1 is a view of tree 8, which I took in an effort to show the poor pruning. In this particular case it seems the people who have tired of the tree are not immediately next door, but at an adjoining property. It's likely that the perpetrators were concerned that the large branch was overhanging the outbuilding. The debris from this operation is simply stacked on the ground over the fence, which somewhat adds to that area's appearance of neglect.

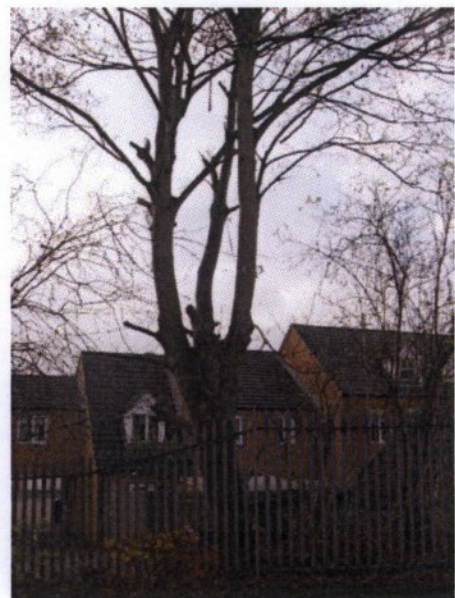
Photograph 2.

7.	Sycamore	13	2 x 500E	M	C1	Outside the site but extremely close to the fence. Has suffered some poor pruning and some vandalism. NB that removal of the car park is almost certain to cause root damage to this tree.	238

Photograph 2 is a view of tree 7, which has also been pruned unsympathetically. This is at the opposite side of the site to tree 8, but it seems the neighbours are similarly annoyed by the trees. It isn't obvious where the site boundary is at this point, it seems the boundary fence has been diverted around the tree, it follows the easiest line rather than the actual boundary.

With tree 7 (in photo 2), apart from the fact that the wooden fence beyond has fallen down, it is possible that both adjoining landowners have attempted to dis-own the trees.

I don't know what is planned for this site but I consider it would be wise for the actual ownership and responsibility for these trees to be ascertained before finalising the proposal.

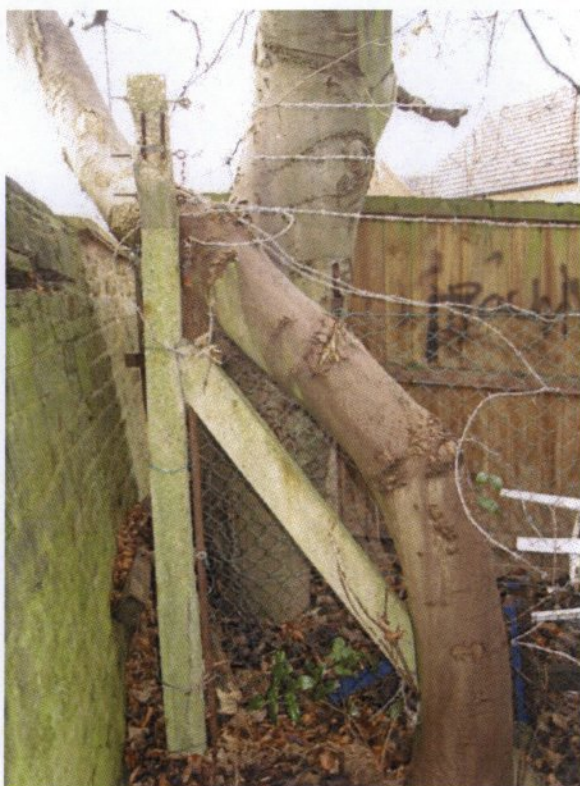
Photograph 3.

Photograph 3 shows the base of tree 2, in the foreground and tree 3 in the background. Note that the boundary fence is tangled with tree 2, it is not worth attempting to retain tree 2. This sort of thing, tree trunks with wire in the middle are extremely difficult to deal with as chain saws will not cut wire. I presume that the concrete post is on the site's proper boundary and the wooden fence was erected to simply create an out-of-sight, out-of-mind situation. In this case it's out-of-site as well!

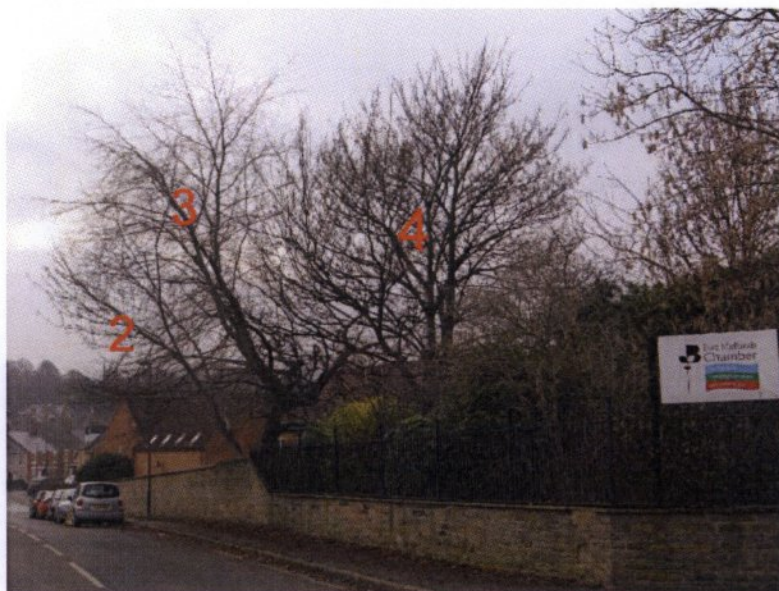
Photograph 4.

Photograph 4 is a view of trees 2, 3, and 4 from the roadside. The Beech tree 3 is a reasonably interesting shape although it's obviously going to need some maintenance work in the near future. This means removing tree 2 and ensuring that it is clear of the road.

We also need to ignore the vandalism and presume that tree 3 didn't suffer root damage when the neighbouring houses were built. It is something of a moot topic but it should be understood that removing a competing tree could be regarded as maintenance of a companion, which is the case here with trees 2 & 3. Tree 3 really needs tree 2 to be removed if it is to grow unhindered.

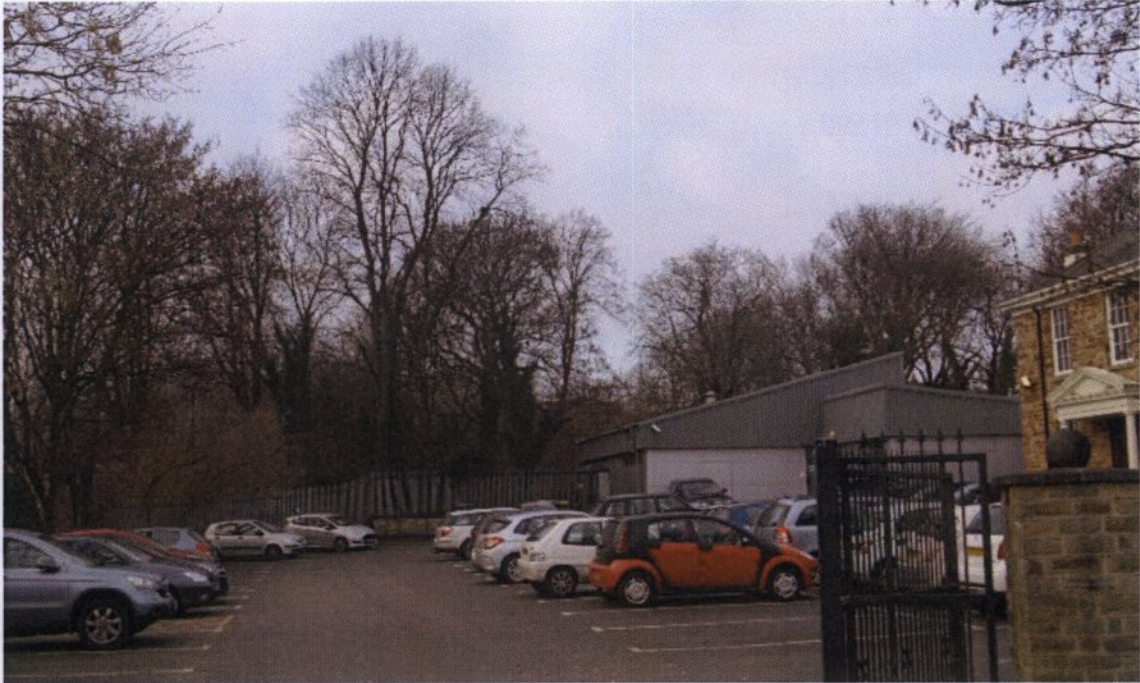
Photograph 5.

Photograph 5 is a view of the site from the car park entrance. Trees in the background are mainly in group 16, the larger tree in the centre is a Lime and is protected under the TPO. The trees at the right, between the grey roof and the stone building, are trees 8-10 (also TPO protected).

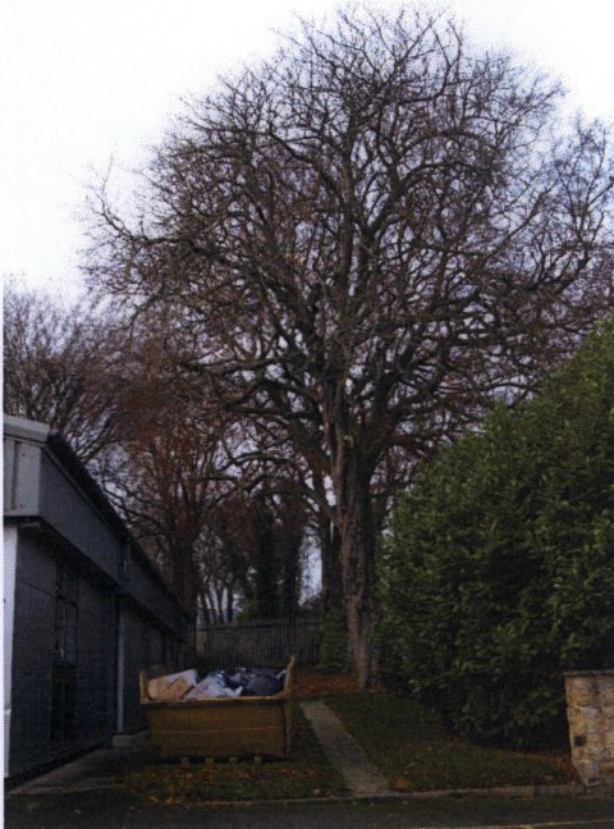
Photograph 6.

Photograph 6 is a view of trees 8-10 from the Hazlehurst Avenue car park. Well it's more tree 10 hiding trees 8 & 9, but it shows the trees' proximity to the grey building. (These trees are TPO-protected.)

I estimated the Beech tree's (9) distance from the building to be less than 7 metres and there is a footpath around the building. This means that this building was erected well within what is now recognised as the tree's RPA. To make matters worse there is a concrete slab between tree 9 and tree 11. I presume there was once a shed of some sort. If the slab has to be removed then heavy machinery will no doubt be working well within all these trees' RPAs.

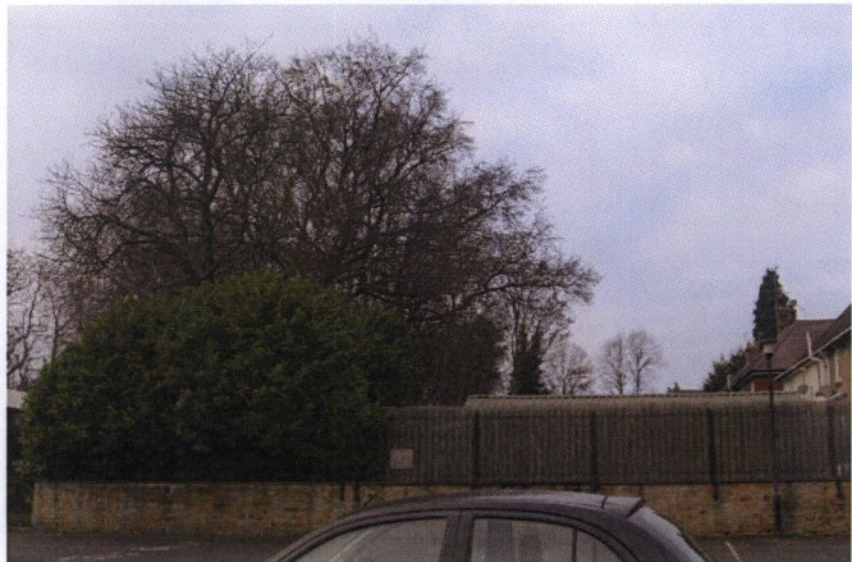
Photograph 7.

I took photograph 7 in an effort to show trees 8-10 in relation to the neighbouring houses. It wasn't entirely obvious at the time of my visit (it was dull) but these trees are exactly to the south of these properties and I'm sure that the occupants regard them as a severe shade-nuisance.

The evergreen shrubbery in this photo is Cherry Laurel and is within the site; the stone wall extends beyond the neighbouring house's boundary. I mentioned above that Cherry Laurel is an invasive pest, which is almost certain to be included in the next revision of schedule 9¹. That is the list of species that contains such species as Japanese Knotweed and the Grey Squirrel.

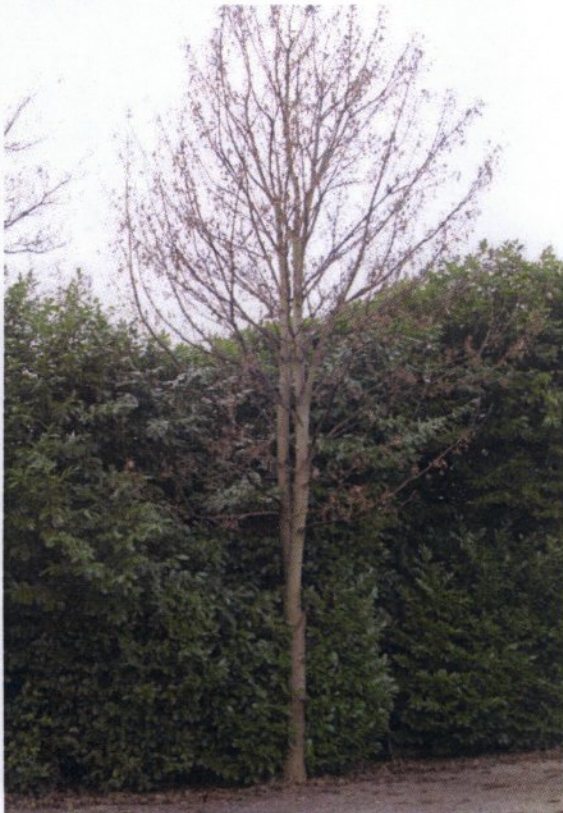
Photograph 8.

Cherry Laurel is non-native and suppresses other (native) species and is almost as much of a nuisance as Rhododendron in urban woodlands. Photograph 8 shows tree 6 with yet more Cherry Laurel between it and the site's boundary.

It is my opinion that invasive species are an under-appreciated threat to the nation's landscape and looking upon plants like this without considering how they might develop would be a mistake. If nothing else the expense of their management is not inconsiderable and managing a shrub of this size is already beyond the capabilities of the average householder or even a domestic DIY enthusiast. Merely getting rid of the debris will require a commercial wood-chipper and taking a chain saw to this sort of plant is not a task for an amateur.

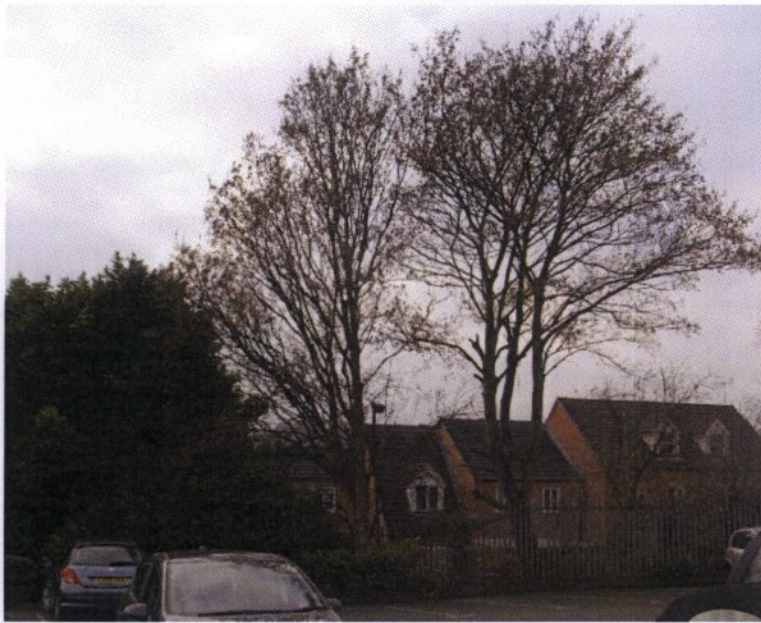
Photograph 9.

I took photograph 9 in an effort to show trees 6 & 7 in relation to the houses beyond and also the adjacent Cherry Laurel.

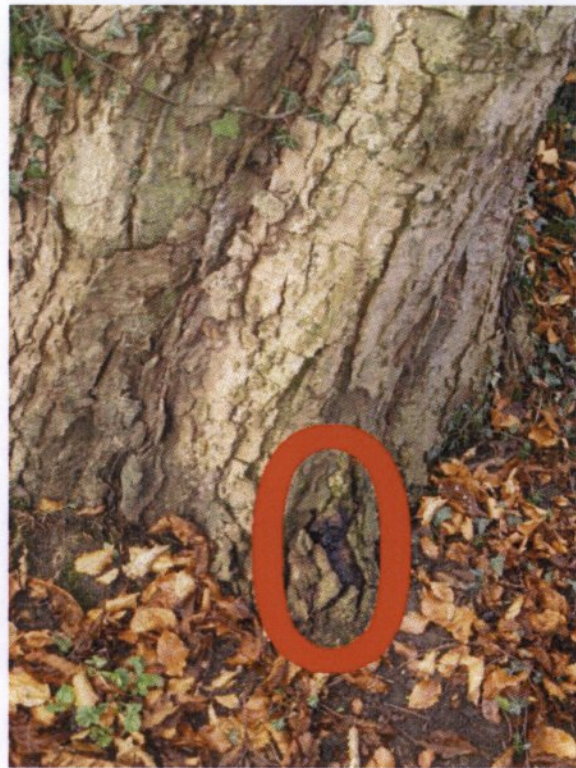
Photograph 10.

As well as invasive species there are a number of tree diseases that are threatening the Country's tree-stock. The small black stain at the bottom of tree 8's trunk may not look like very much but is actually a symptom of Horse Chestnut Bleeding Canker. This is a disease (diseases?²) that is widespread at the moment and regarded as something of an epidemic.

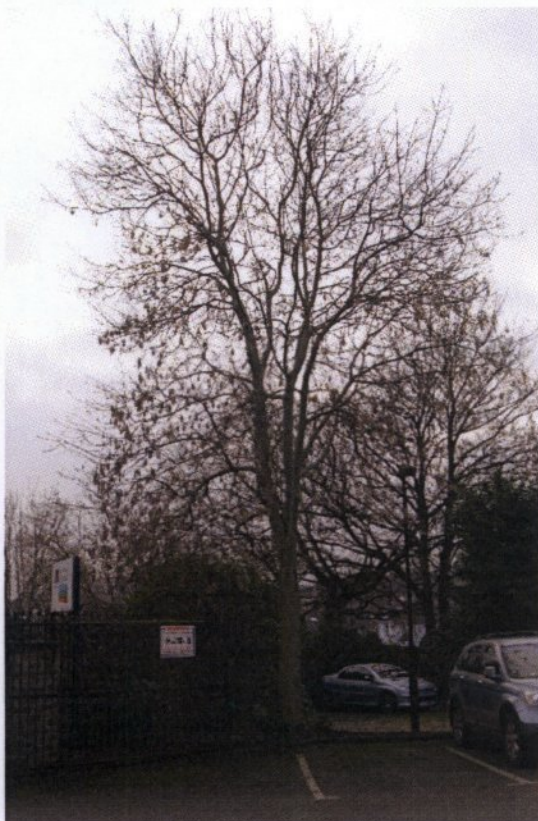
Photograph 11.

Photograph 11 shows tree 1. While this is superficially a decent tree, I am forced to ask how the car park surfacing at its base might be removed without causing root damage. Removing the tarmac by hand might seem simple enough but in reality by the time the tarmac's sub-base is removed some root damage is almost certain to have been caused. Clearly it's a young-ish tree and therefore ought to be reasonably resilient to such disturbance, but there is always a risk that it would not survive. Therefore asking if it would not be better to simply remove it and plant a new tree when construction work is complete is an entirely reasonable question.

In the case of tree 1 I consider the sensible option would be to remove the tree and plant a new one when the surfacing is removed. This might seem like a luddite-solution but a tree like this does not offer any unusual value to biodiversity and a similar new tree could be fairly readily grown. If the tree was retained then the worst possible outcome would be for it to be affected by the nearby works, for it to then spend several years as a moribund nondescript specimen before finally dying. When looked at in this way the replanting option, enforced via planning condition, seems a far better outcome.
