Chesterfield Non . Traditional Housing

Structural Survey of Non Traditional Housing Stock

Curtins Ref: NO1033

Issue Date: 21 May 2014

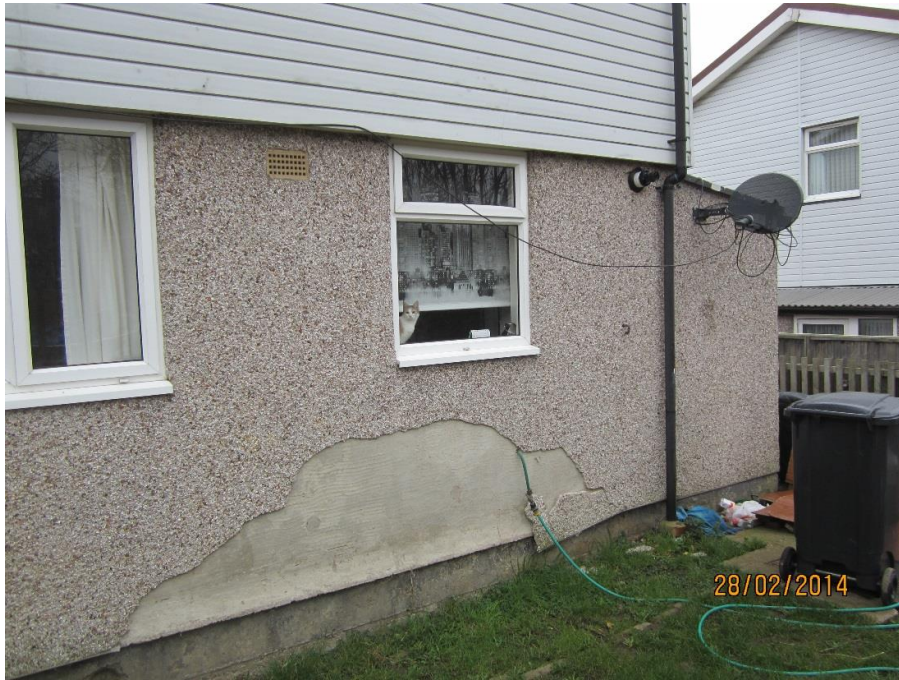
The refurbished walls appear to be performing satisfactorily. We did note however that there are some vertical cracks in the render which may coincide with the location of the steel columns and areas of debonded render.

Debonded Render

- Remove existing cladding in order to inspect the existing steel frame.
- Make any repairs necessary to the steel frame. Paint all steel columns up to a height of 500mm with a bitumen paint.
- Fix 18mm marine quality plyboard to the steel frame.
- Fix external insulation to the plyboard.

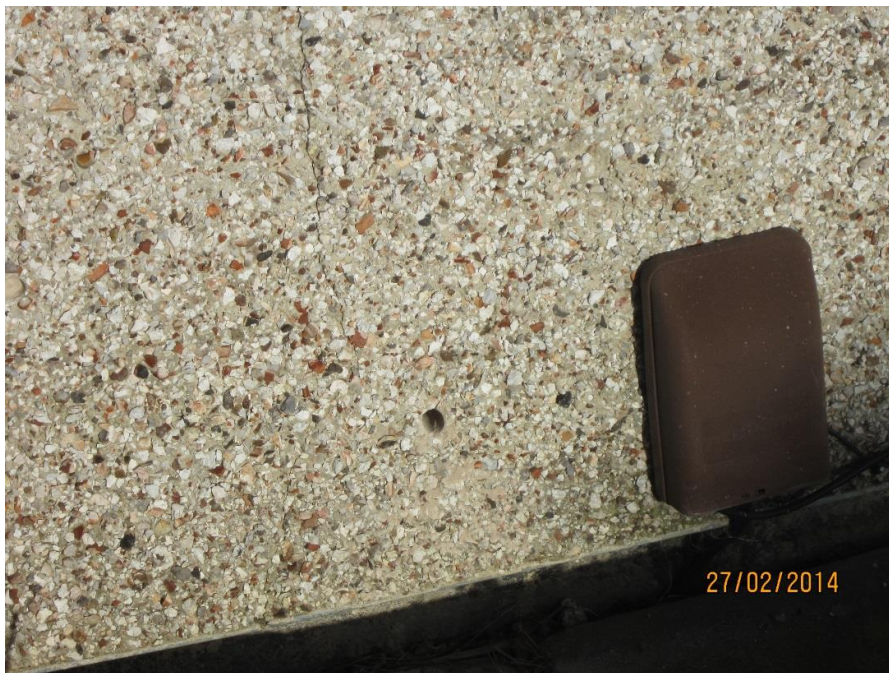
Cracked Render

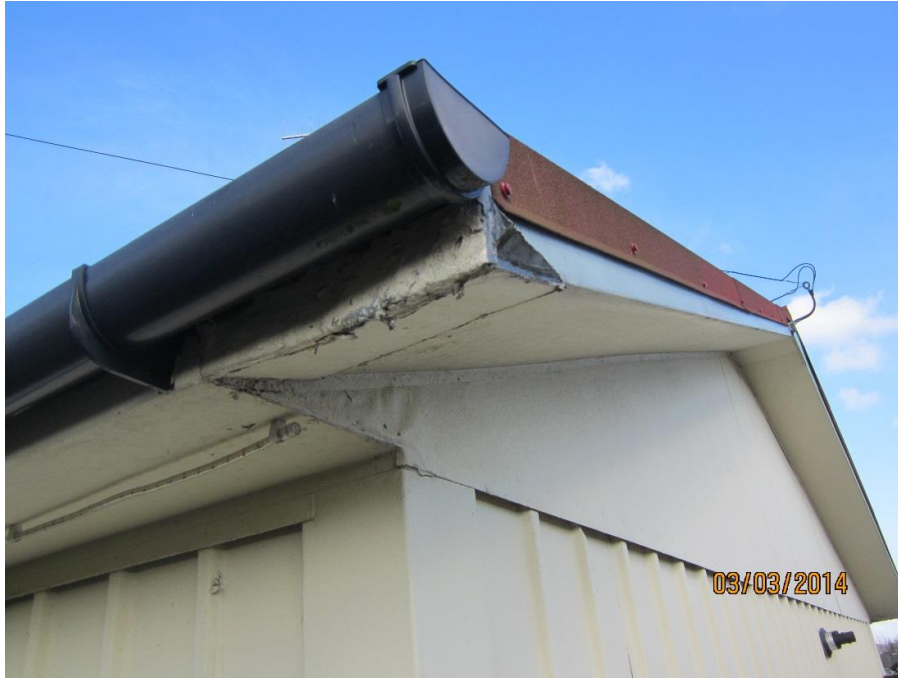
Decay at Fascia

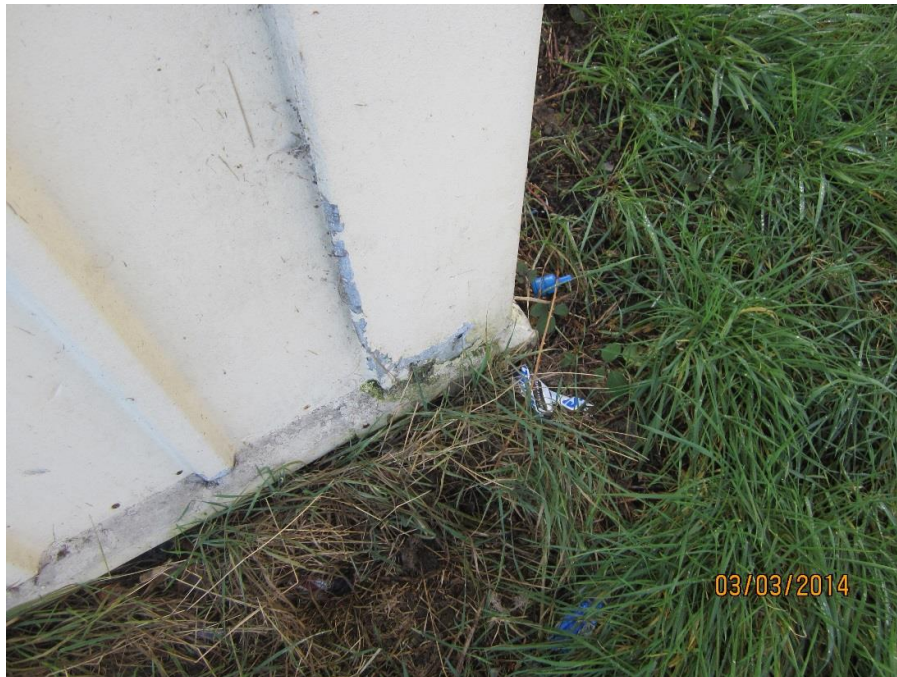
- d) External Walls The aluminium profiled sheeting is relatively satisfactory. There are areas of flaking paint particularly on the soffit and some sheets are deformed and some isolated areas of decay.

Damage to Cladding

- Remove the bottom 500mm of the existing sheeting, inspect the structural frame, make good any defects and fix 18mm marine quality plyboard.
- Supply and fix treated battens and boarding to the existing structure. Fix new external wall insulation.
- Supply and fix new GRP canopy.

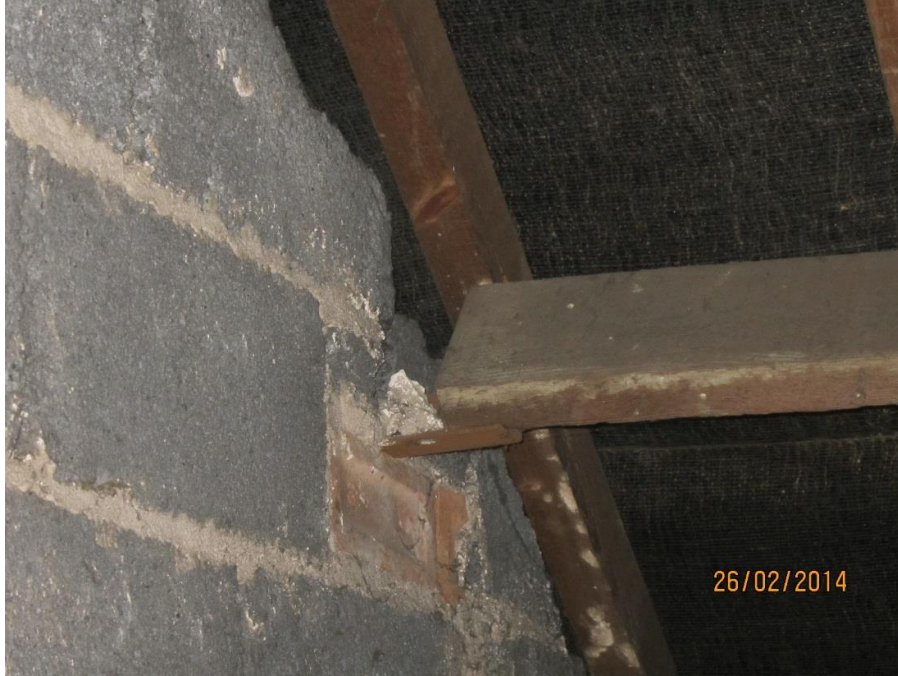
c) Roof Construction	The roof construction, including the mansard is of a traditional roof construction of purlins and rafters. The timber purlins bear onto the party wall by means of a steel angle. The bearing on some purlins is relatively short and should any decay occur at the bearing end the bearing stability would be suspect, however at present it is satisfactory.

Poor Bearing for Purlin

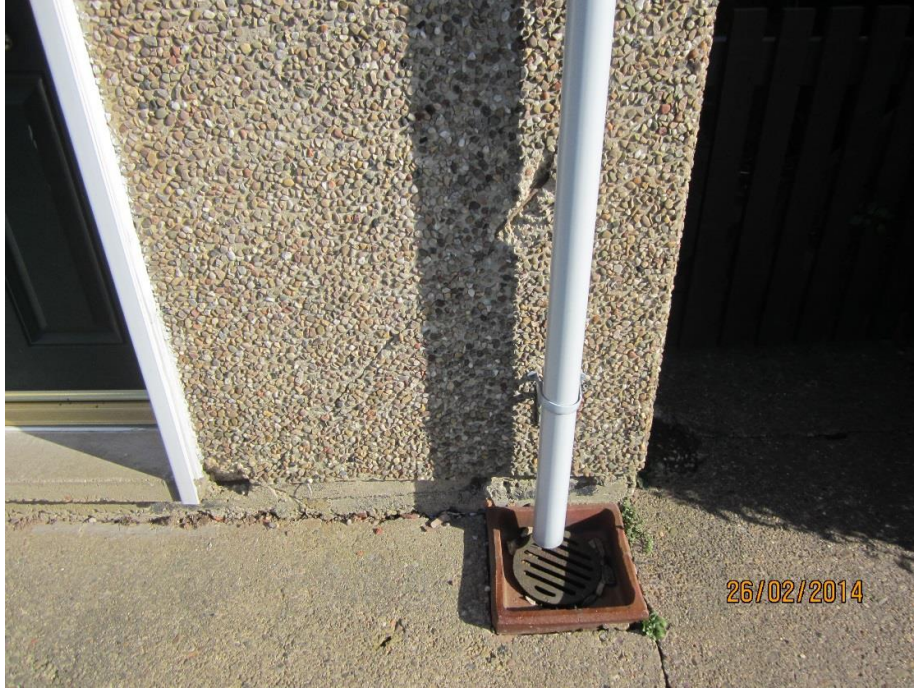
Cracked Panel

- Make good all joints.
- Undertake all concrete repairs.
- Supply and fix external wall insulation.
- New flat roof covering.

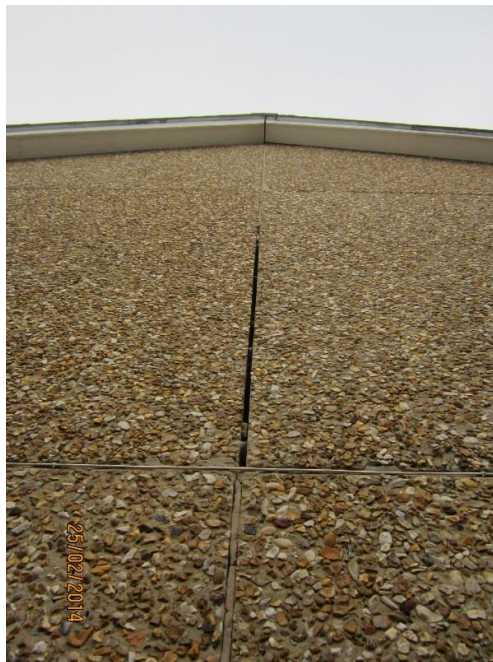
Open Joint

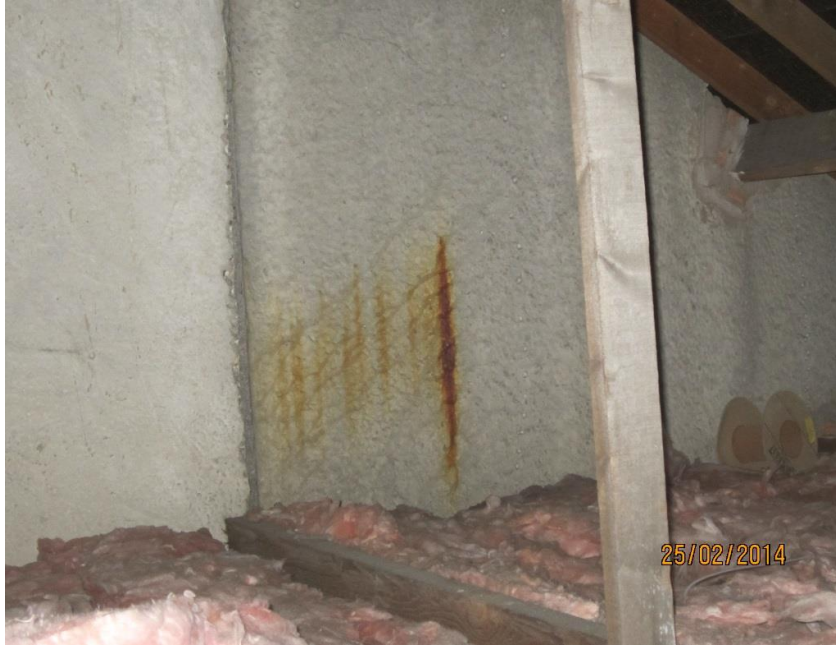
Rusting Reinforcement to party wall in roof

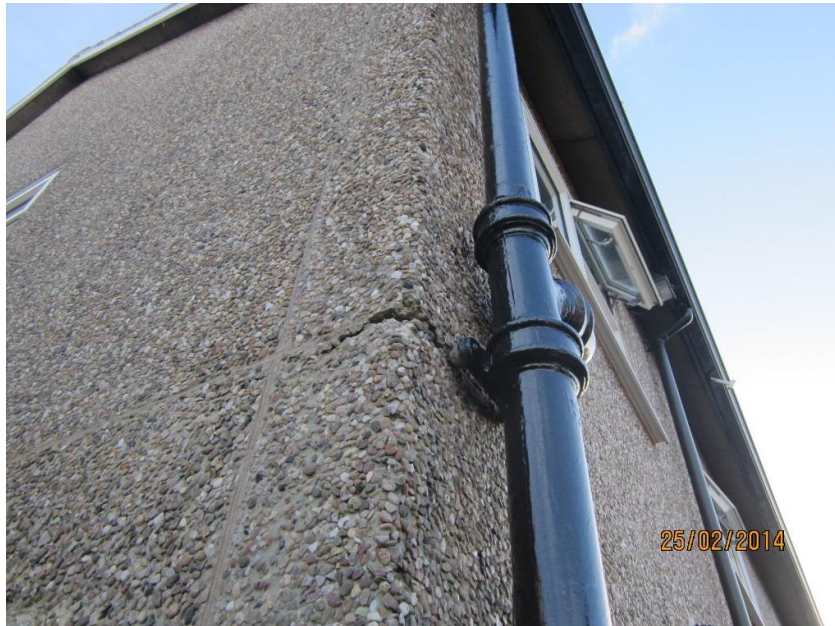
Cracked & Spalled Concrete

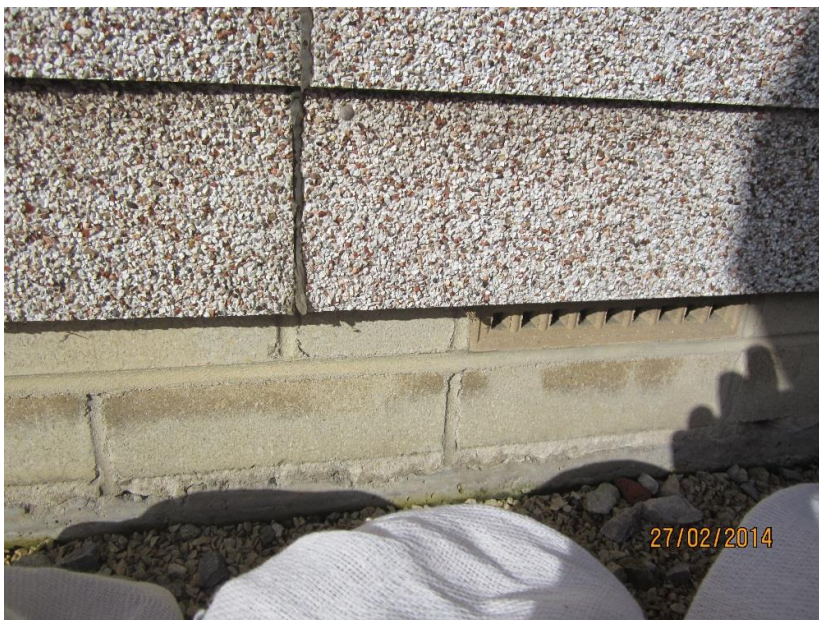
- d) Ground Floor The suspended ground floor appeared to be performing satisfactorily with no evidence of structural movement. We noted however that the bottom spa dashed panel partially covered the air vents. This will restrict the free air flow under the ground floor and could result in decay of the ground floor joists.

Existing Cladding Obstructing Ventilation

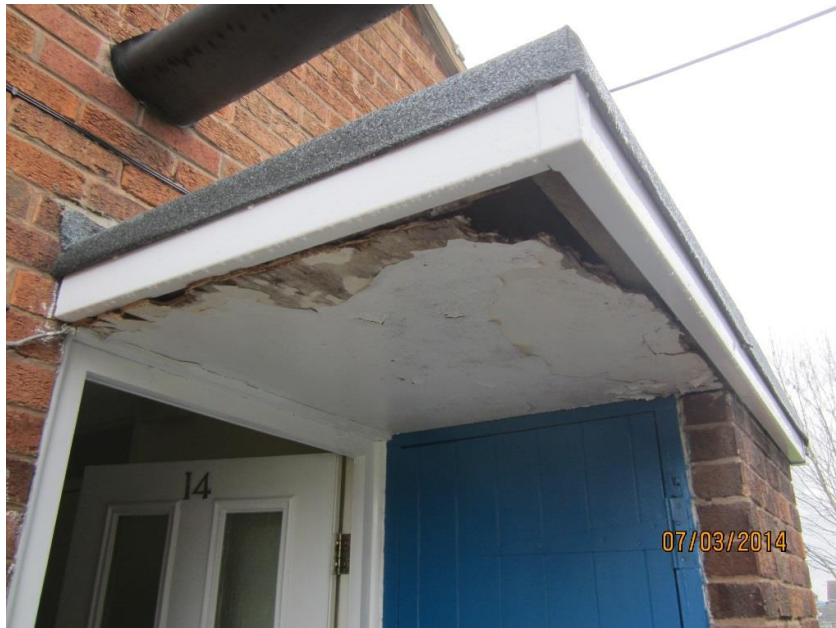
The cantilevered canopies over the entrance doors were showing signs of movement as the fixings are beginning to fail.

Damaged Canopy

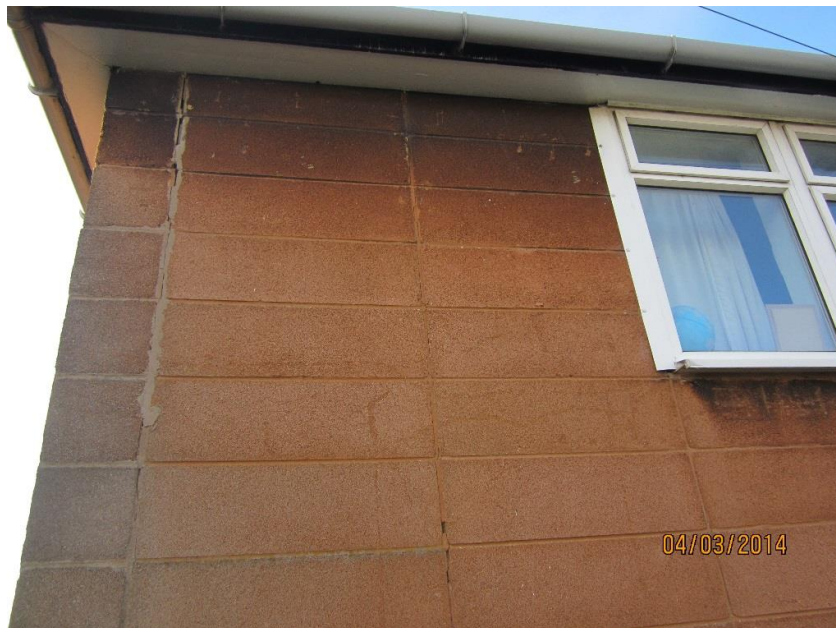
Cracked & Open Joints

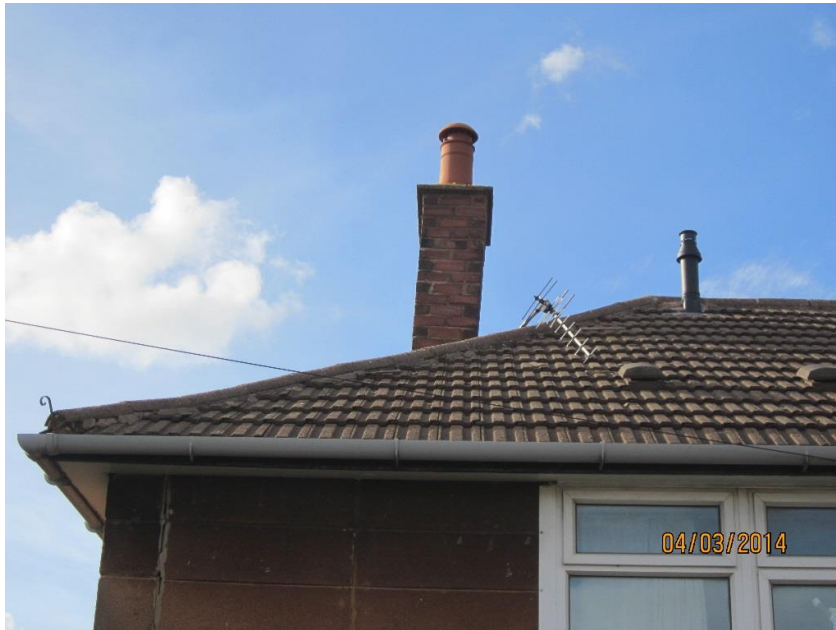
Chimney Leaning

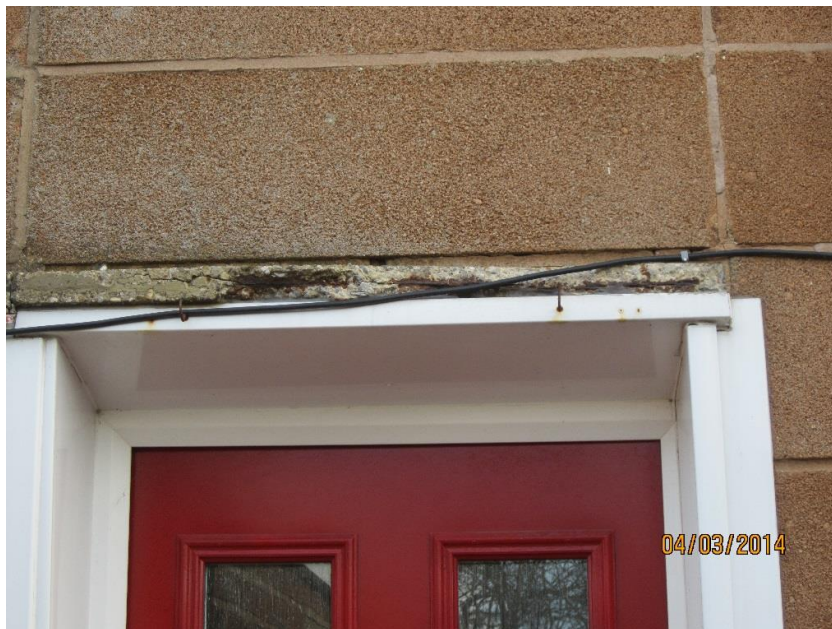
Exposed Reinforcement over Doorway

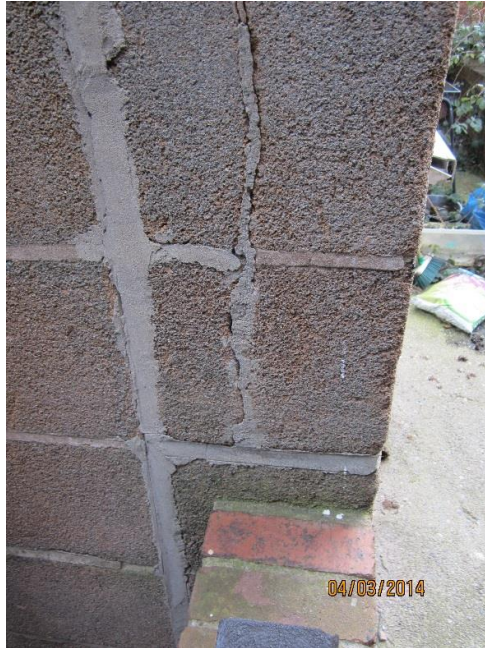
Cracked Panels
